USING A TRACKING LASER INTERFEROMETER TO CHARACTERIZE THE PLANARITY OF A PLANAR NEAR-FIELD SCANNER

Paul R. Rousseau, William C. Wysock, and Carlos M. Turano
The Aerospace Corporation
P.O. Box 92957, Mail Stop M1-135
Los Angeles, CA 90009-2957

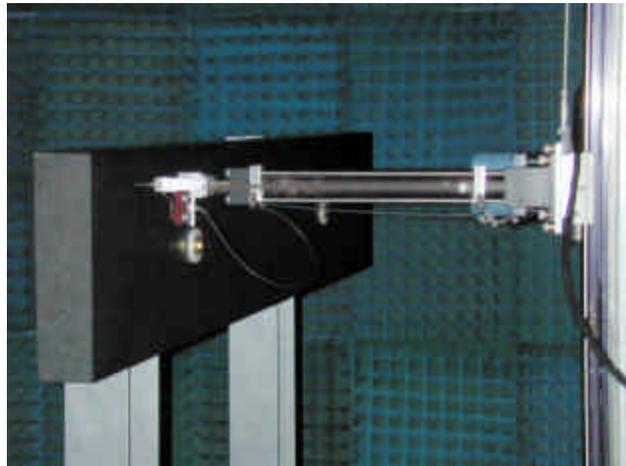
For the next step in the alignment of the scanner, mechanical probe measurements were performed on a large granite block used as a planar reference surface. These mechanical measurements were cumbersome due to the large weight of the granite block (see Figure 3 for a picture of this type of measurement). The granite block measurements also had the limitation that they were only performed along one linear dimension (either vertical or horizontal). In addition, at each sample point in the scan plane, the probe stays at a fixed location while the distance to the granite block is measured.

Figure 3: Photograph of Granite Reference Surface Measurement.

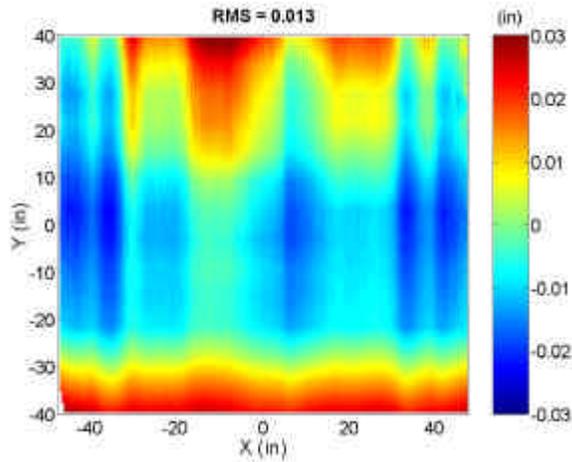
The alignment of the planar scanner proceeded in two steps. The first step was to align the steel horizontal base plate by adjusting the anchor bolts holding the steel plate onto the floor. Figure 8 shows the probe position error, with an RMS of 0.013 inch and a peak-to-peak variation of 0.058 inch, that was initially measured with the tracking laser before any adjustments were made. The probe position error is calculated from the probe position data by computing the position relative to a best-fit planar surface. Planarity data was collected on a 1 inch by 0.5 inch grid with the probe carriage moving at 10 in/sec. The ability to quickly generate graphic depictions of planarity error facilitates the determination of mechanical error sources.

Figure 8: Initial scanner probe position errors with RMS = 0.013" (File: 010816 1342).
